Manhole Inspection Summary

Manhole # S33CC_039MH

Insp Date: **10/17/08 9:36 AM**

Location Address: **250 CHASE ST**

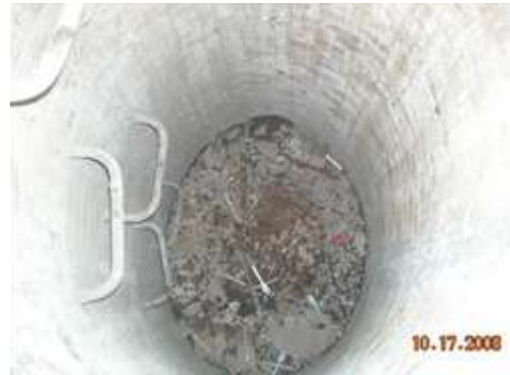
Top View

Channel debris.

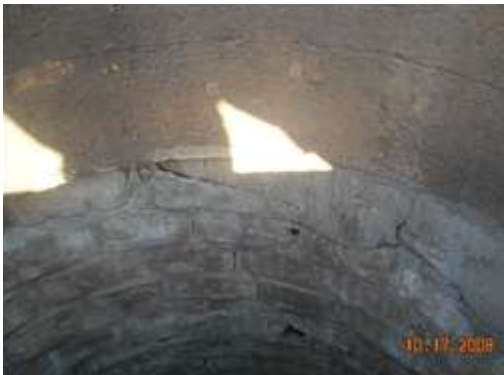
Defect

Frame leaks. Corbel infiltration.

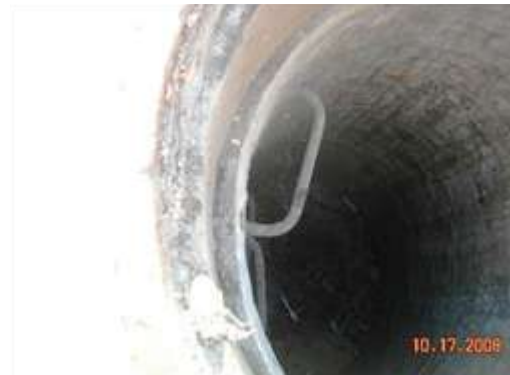
Defect

Frame leaks. Frame offset. Corbel infiltration.

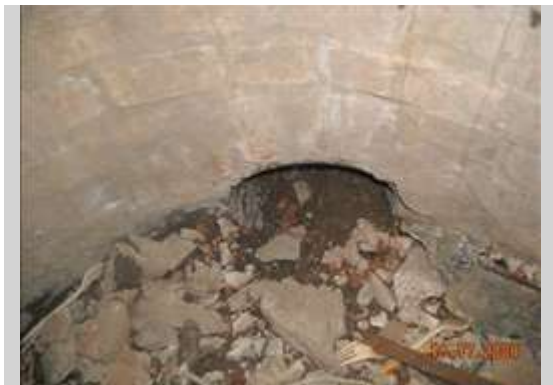
Pipe Out @ 12 O'Clock

Deposits: ☐ None ☒ **Mud** ☐ Sludge ☒ **Debris** ☐ Grease

Silt Depth: **2** (in.)

Deposits Extent: **Light**
